## Devil's Slide/Hwy 1 Storm Repair

Daily Updates from Bijan Sartipi

**Daily Update**  
June 21

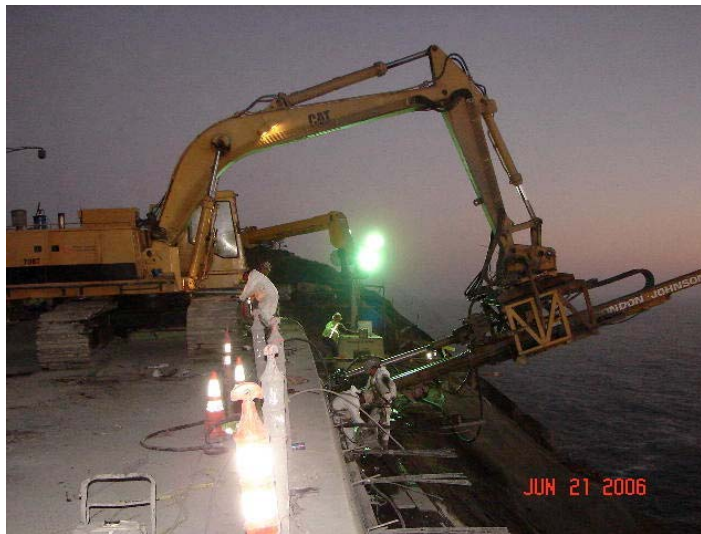
- Whaler wall 'A' (upper level ocean side) – drilling with reach over rig and stressing tie backs continued. 50 of 59 tie backs installed and of these 37 have now been stressed.

Reach over rig drilling at wall A

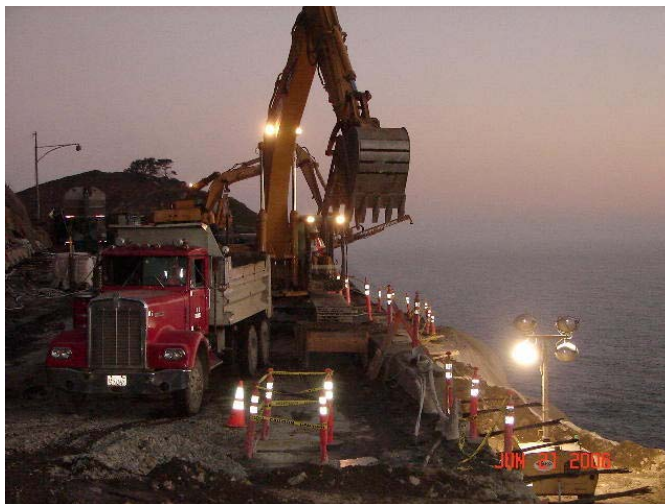
- Whaler wall 'B' (lower level ocean side) – additional drill rig deployed to start drilling at south end of wall B. Excavation work at the north end of the wall continued.

Excavating for wall B

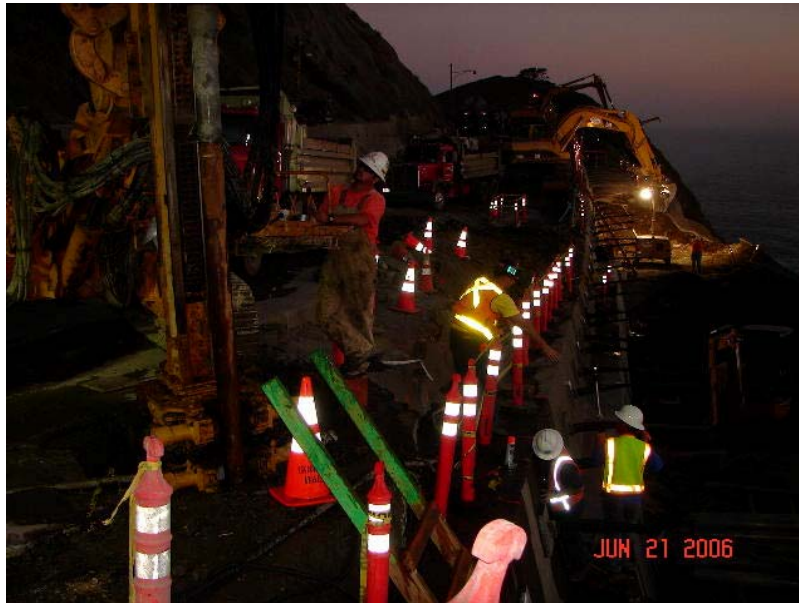
- Whaler wall 'C' (lower level cliff side) – drilling continued. 26 of 34 tie backs now installed.
- Conditions under the roadway are such that stressing tie backs has caused wall A to shift. To prevent this, a technique known as compaction grouting was started overnight. Vertical holes behind wall A are drilled and a cement grout injected to fill voids and solidify the ground under the road.

Drilling vertical holes behind wall A

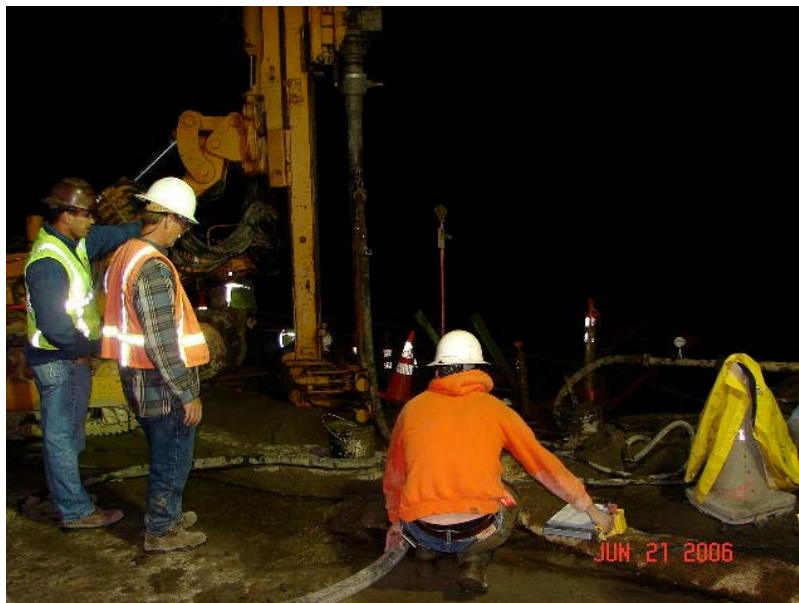
Injecting grout to compact ground under the road
